Post-construction behaviour of two high geogrid-reinforced soil retaining walls for Fujisan-Shizuoka airport

ABSTRACT: For Fujisan-Shizuoka Airport, which opened to service June 2009, two high geogrid-reinforced soil retaining walls, 21.1 m and 16.7 m-high, were constructed to preserve natural environment consisting of forest and steep swamp areas in front of the walls. These areas are to be buried in the backfill if gentle-sloped embankments were constructed. As the walls support the east side of the runway of the airport, it is required to ensure minimum residual displacements and a high stability of the walls during heavy rainfalls and severe earthquakes. Well-graded gravelly soil was selected as the backfill and compacted very well to an average degree of compaction higher than 95 % based on the modified Proctor. A systematic and comprehensive drainage system was installed inside and at the bottom of the walls. The deformations of the walls during and after construction were monitored, which showed very small deformation during and after construction. The recorded tensile strains in the geogrid also indicated a high stability of the walls. This case history shows that very sti

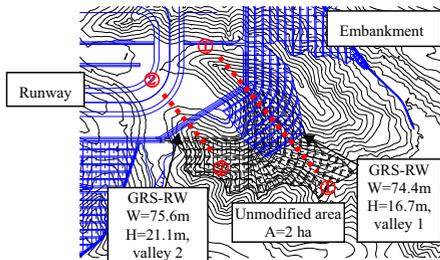
Fig. 3. Plan view of the eastern end of the runway (①-① and ②-② indicate cross-sections shown in Fig. 4)

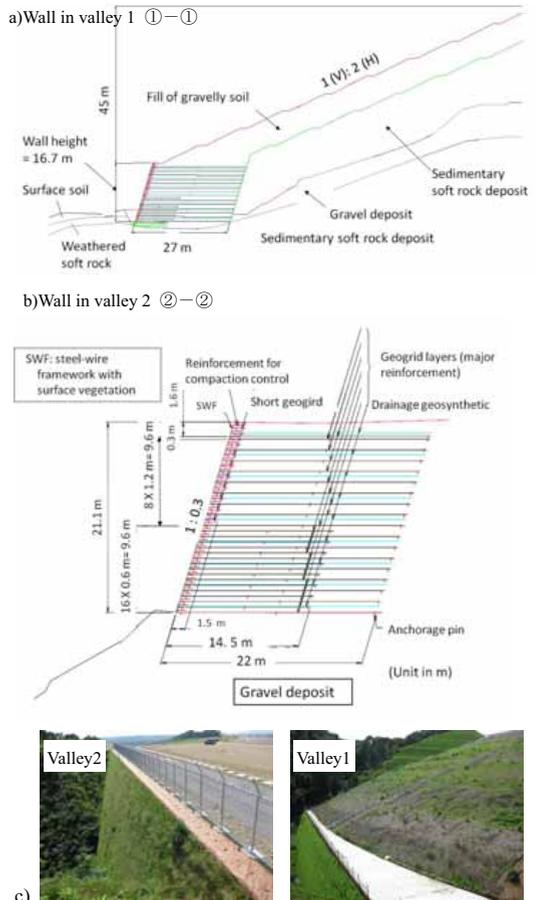
Fig. 4. Cross-sections of the two GRS-RWs

In valley 2, the first geogrid-reinforced soil (GRS) retaining wall was constructed (Fig. 4b). The suppor-

The two walls were carefully designed by evaluating the internal and external stabilities under static and seismic loading conditions. The pseudo-static limit-equilibrium stability analysis with a horizontal seismic coefficient equal to 0.20 was performed. As a result, the GRS wall in valley 2 became the highest one in Japan (i.e., the height is 21.1 m with a crest width of 75.6 m, Fig. 4b). The length of the primary geogrid layers was 22 m. The GRS wall in valley 1 has a height of 16.7 m with a crest width of 74.4 m. The maximum length of the primary geogrid layers was 27 m. A 45 m-high embankment with a slope of 1.0:2.0 (V:H) was constructed on the back of the GRS wall to accommodate an elevation difference of 40 m between the airport and the crest of the GRS wall (Fig. 4a). This configuration was determined so as to as much as possible preserve the forest in front of the wall. The plan configuration of the embankment on the slope is curved to mitigate stress concentration inside the embankment and to reduce the amount of the backfill. The wall faces of the two GRS walls were vegetated (Fig. 4c).

The performance of the two GRS walls is presented in Figs. 9 and 10. The total vertical compression of the geogrid-reinforced backfill during construction (see Fig. 4 for the locations of measurements) is only 0.3 % (the wall in valley 1) and 0.5 % (the wall in valley 2) of the respective completed wall heights. Furthermore, the post-construction residual compression of the two walls was negligible. In particular, the deformation during a number of heavy rainfalls was negligible. This very high performance was due largely to the fact that the reinforced backfill was compacted very well (Fig. 8). On the other hand, relatively large compression took place during and after construction in the embankment constructed on a slope in valley 1 (Fig. 5a). This is due likely to that the backfill was not reinforced, therefore the compaction work was relatively difficult, and a larger compacted lift (i.e., 40 cm) was employed, despite the use of heavier compaction machines (a 18 tonf-class vibratory compactor). In particular, compaction efficiency is generally higher when the backfill is reinforced than when not, because lateral yielding of the reinforced backfill when subjected to heavy compaction load is better restrained. This high wall performance can also be attributed to effective drainage systems arranged inside and at the base of the backfill.

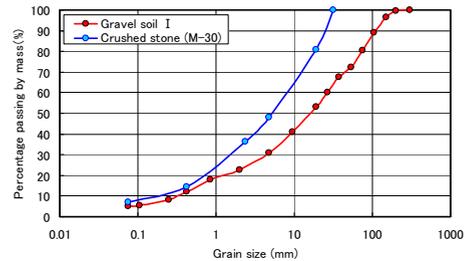
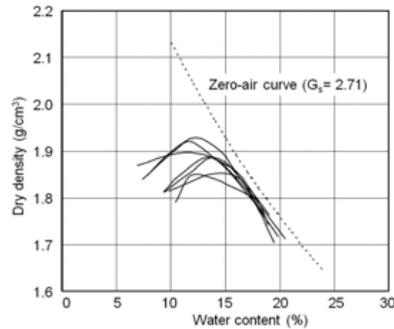
Fig. 6. a) Grading curves; and b) compaction curves (modified Proctor) of the main backfill

The backfill of the main body of the walls was well-graded gravel from a nearby ancient riverbed that has tectonically heaved to above the sea level (gravel soil I, Fig. 6a), which composes round large particles and sub-angular fine particles. The design shear strength parameters of the backfill were an angle of internal friction equal to 35 degrees and a

A vertical 50 cm-wide zone composing gravel of graded crushed stone from a quarry (M-30, Fig. 6a) was arranged immediately behind the wall face to smoothly discharge toward the bottom of the wall face the water from the drainage geosynthetic strips as well as permeated rain water.

Radio Isotope method, performed eleven times at each place per an area of 1,000 m². Fig. 8 shows the histograms of the D_c values in the reinforced zone. The mean D_c values in valleys 1 and 2 were 98.0 % and 97.5 %, respectively, with standard deviations of 2.85% and 2.75% (i.e., a coefficient of variation equal to 3 %). These values fully satisfy the specified allowable lower limits (Table 1) and indicate that the backfill was compacted very well. The water content was also controlled during construction not to exceed 16 %, which is slightly wetter than the optimum water content (Fig. 6b).

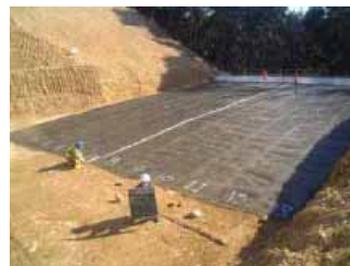
Fig.7. Installation of geogrid layers

Different types of geogrid made of Aramid fibre coated with HDPE having design tensile strengths ranging from 20 to 87 kN/m were used to reinforce the major part of the backfill. Fig. 7 shows a geogrid layer placed on the compacted lift of the backfill. Installation damage to the geogrid when the reinforced backfill is compacted using 10 ton-class vibrating roller compactors was evaluated by performing tensile loading tests of the samples of the aforementioned three types of geogrid retrieved from the backfill reinforced with geogrid layers as the actual walls in test compaction tests. It was found that the installation damage can be ignored.

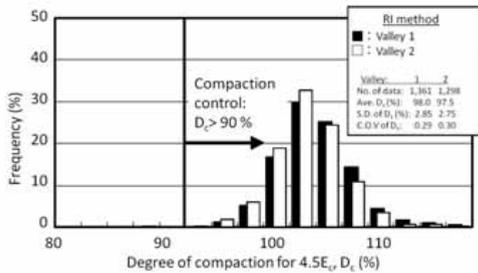
Fig. 8. Histogram of degree of compaction D_c

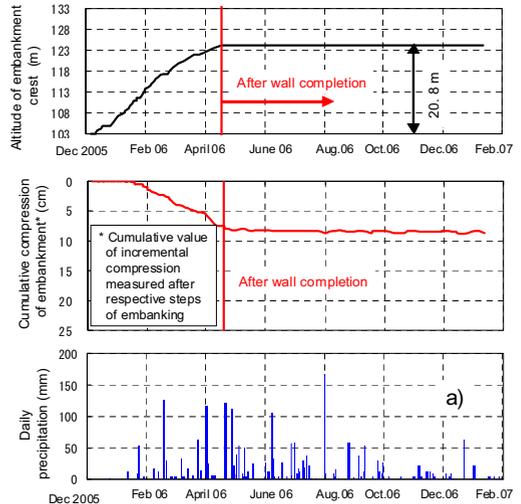
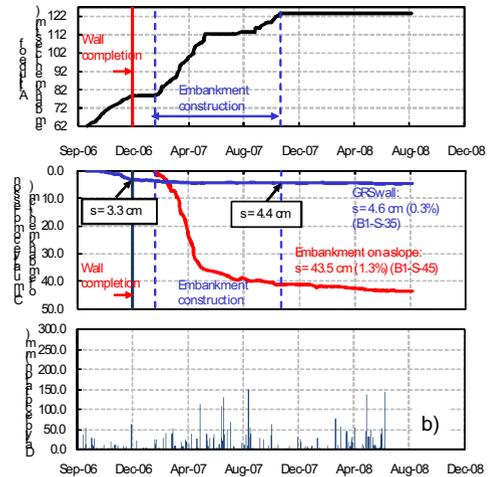
Fig. 9 a) Deformation of the wall and embankment on a slope, valley 1; and b) deformation of the wall, valley 2

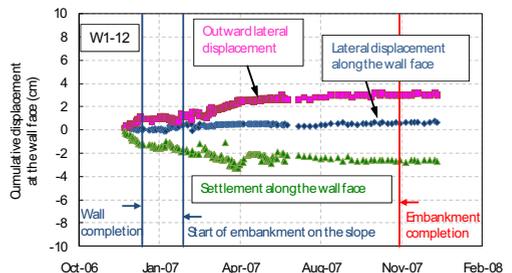
Fig.10. Displacements at the wall face, 13th geogrid layer in the GRS wall in valley 1.

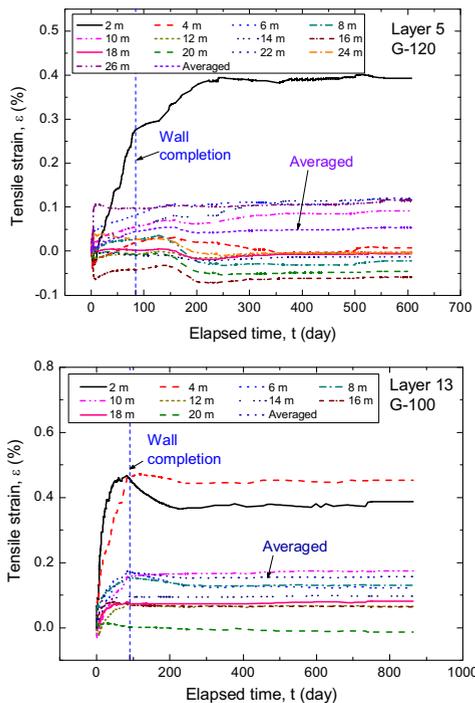
Fig. 11. Tensile strains in representative geogrid layers

Fig. 11 shows the time histories of tensile strain at a 2 m-interval in representative geogrid layers (i.e., fifth layer in valley 1 and 13th layer in valley 2). The tensile strain increased at relatively high rates during wall construction. The largest strain at the end of wall construction was about 0.5 %, observed at 2 m from the wall face, which was much smaller than the strain at rupture in tensile loading tests of the geogrid (i.e., 4 %). This trend of geogrid strain indicates that there exists no sign showing the global failure of the walls. In the wall in valley 1, the increase in the strain continues by the end of construction of the embankment on the slope, which is consistent with the displacement at the wall face (Fig. 10). More details of the tensile strains in the geogrid and their analysis to estimate the tensile forces are reported elsewhere (Kongkitkul et al., 2010).

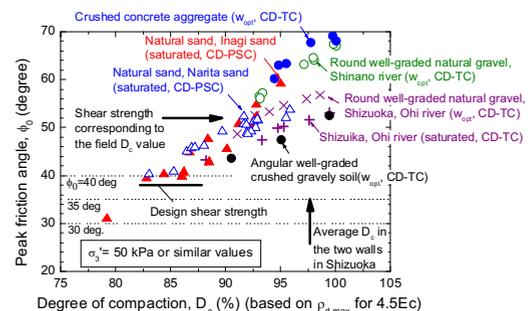
Fig. 12. Summary of $\phi_0 - D_c$ (for $4.5E_c$) relations from drained TC and PSC tests at confining pressures of around 20 - 50 kPa. Note: w_{opt} in the parenthesis indicates that, when tested, the specimens were moist; and the others were saturated (Kiyota et al., 2009).

As shown above, these two walls have been very stable, exhibiting deformations much smaller than those anticipated at the design stage. This would be due to the following two factors, in addition to relevant reinforcing of the backfill: 1) the arranged drainage systems were effective; and 2) high-quality backfill was well compacted and the actual strength of backfill was much higher than the design shear strength (i.e., an angle of internal friction =35 degrees and a cohesion= 8.5 kPa). The design shear strength parameters are equivalent to a peak friction angle to the origin, $\phi_0 = \arcsin[(\sigma'_1 - \sigma'_3) / (\sigma'_1 + \sigma'_3)]_{\max}$ when $\sigma'_3 = 50$ kPa equal to 39 degrees. Fig. 12 summarizes the relationships between ϕ_0 and D_c (for $4.5E_c$) from many series of CD TC and plane strain compression (PSC) tests performed at typical operated confining pressures in the field (mostly $\sigma'_3 = 50$ kPa) on a wide variety of sandy and gravelly types of backfill. The data from a new series of CD TC tests at $\sigma'_3 = 50$ kPa on specimens of gravel soil I (Fig. 6a) produced by compaction at the optimum water content (for $4.5E_c$) are included in these data. The CD TC tests were performed either at the moist condition as compacted (i.e., the data points x) or after having been made fully saturated (i.e., the data points +). The moist specimens are noticeably stronger than the saturated ones. The design shear strength corresponds approximately to $D_c = 85\%$ of the fully saturated specimens, which is even lower than the allowable lower bound 90 % in the field compaction control, while substantially lower than the average values of the actual D_c values, 97.5 % and 98 % (Fig. 8). This fact means that, even when fully saturated, the actual shear strength of the backfill is substantially higher than the design value.
